INVESTIGATION REPORT INTO CAUSE OF FIRE AT MAKERERE UNIVERSITY MAIN BUILDING

Task Force on the Cause of Fire at
Makerere University Main Building

November 2020

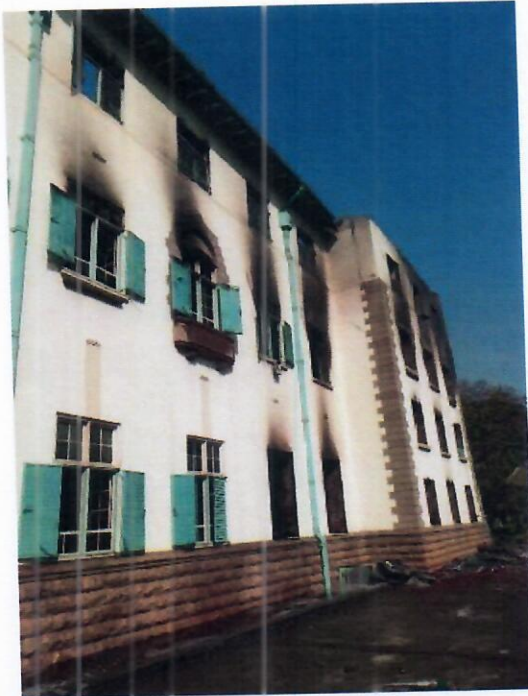
Figure 2: Front of Northern Wing of Main Building Showing with Smoke on Windows

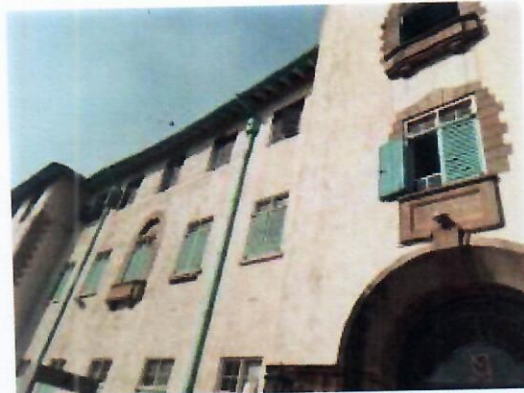
Figure 3: Main Entrance and Front of Southern Wing of Main Building

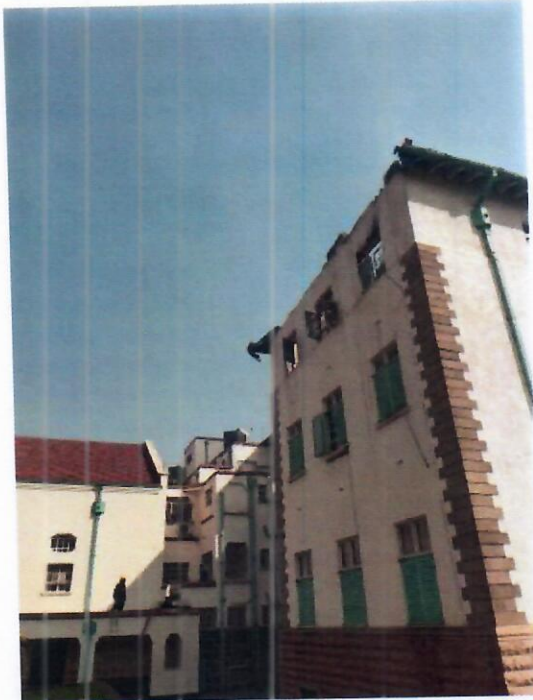
Figure 4 shows the back of the southern wing of the Main Building with burnt windows on the second floor and no roof. Figure 5 shows debris behind the southern wing of the building.

Figure 4: Back of Southern Wing of Main Building with Burnt Windows on Second Floor and No Roof

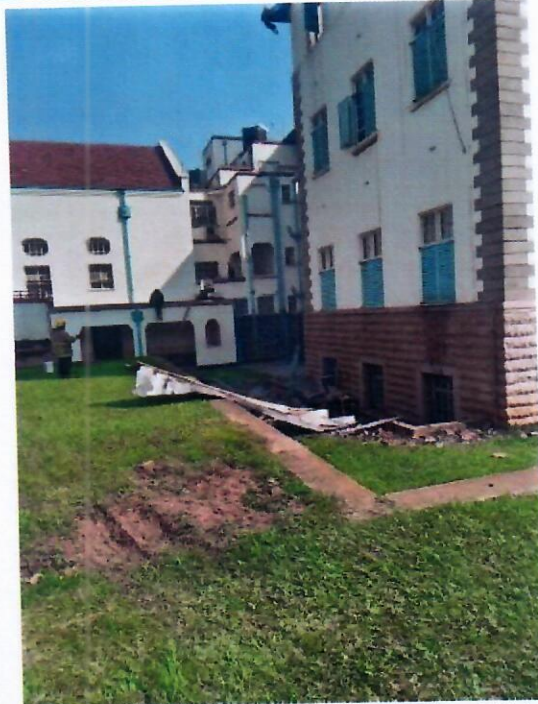
Figure 5: Debris Behind Southern Wing of Main Building

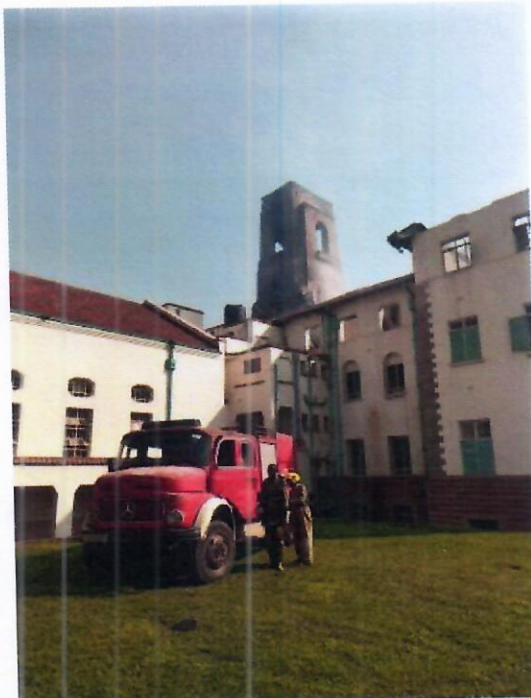
There was smoke coming out of the tower of the building (Figure 6). There was a lot of heat in the northern wing of the building and the water poured into the building by the fire brigade was steaming (see Figure 7).

Figure 6: Smoke Coming Out of Tower of Main Building

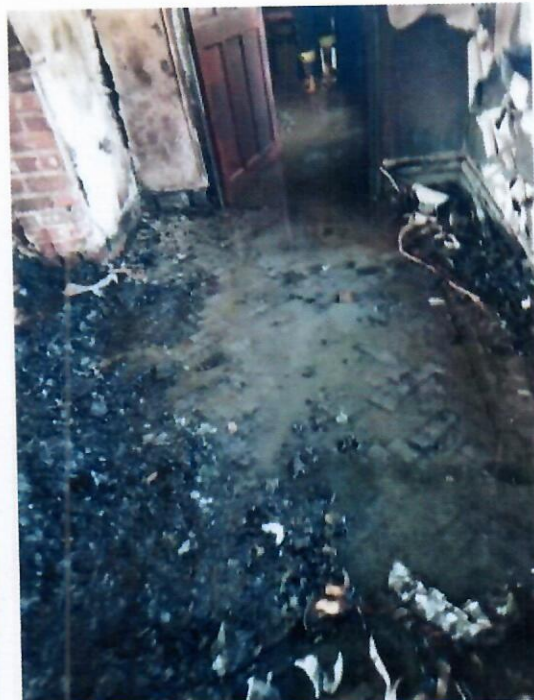
Figure 7: Hot Water from Fire Truck in Corridor of Southern Wing of Main Building

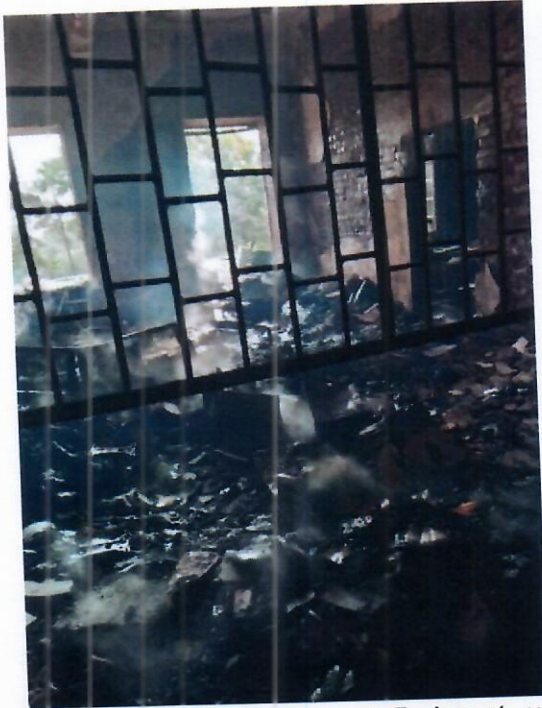
The ground floor of the northern wing of the building had burnt furniture and equipment as shown in Figure 8. There was smoke in the northern wing of the building (Figure 9).

Figure 8: Burnt Furniture and Equipment on Ground Floor Office, Southern Wing of Main Building

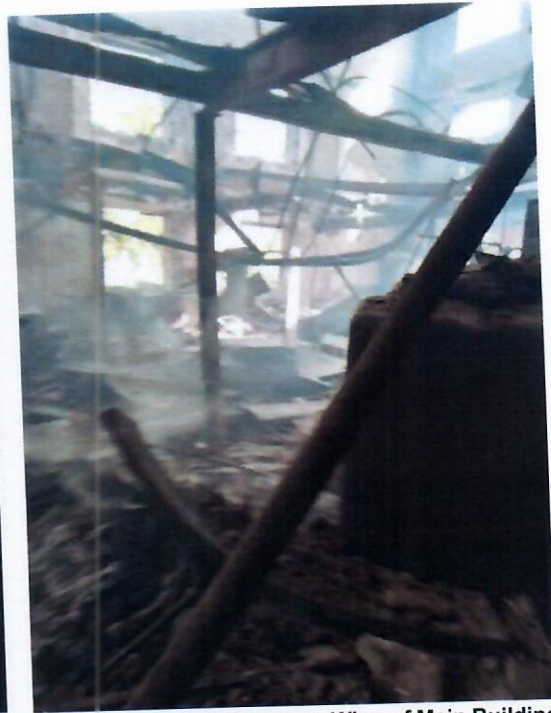
Figure 9: Smoke in Northern Wing of Main Building

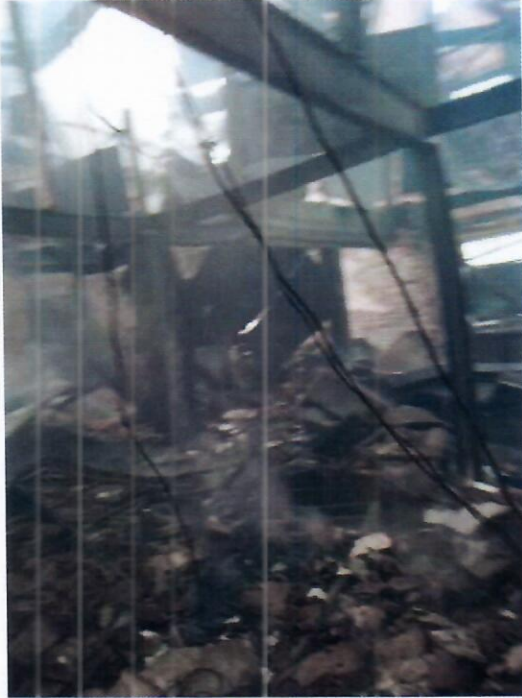
Figure 10 shows smoke going through the roof of the northern wing of the building. Figure 11 shows a bookshelf on a steel beam on the burnt out first floor.

Figure 10: Smoke Going through Open Roof of Northern Wing of Main Building

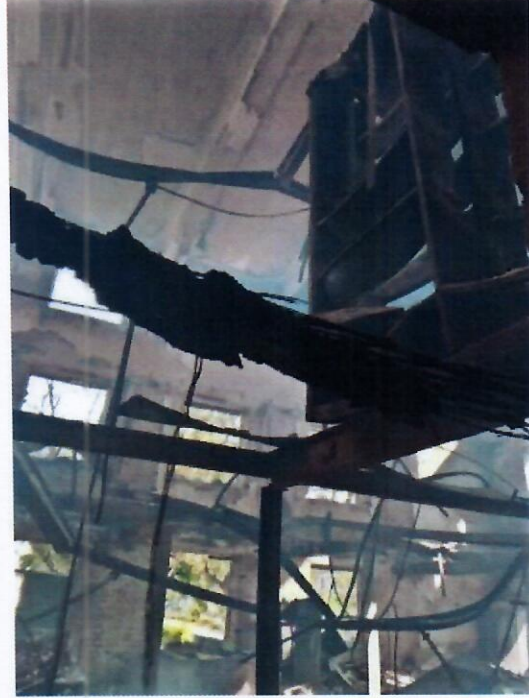
Figure 11: Burnt Out First Floor, Southern Wing of Main Building with Hanging Bookshelf

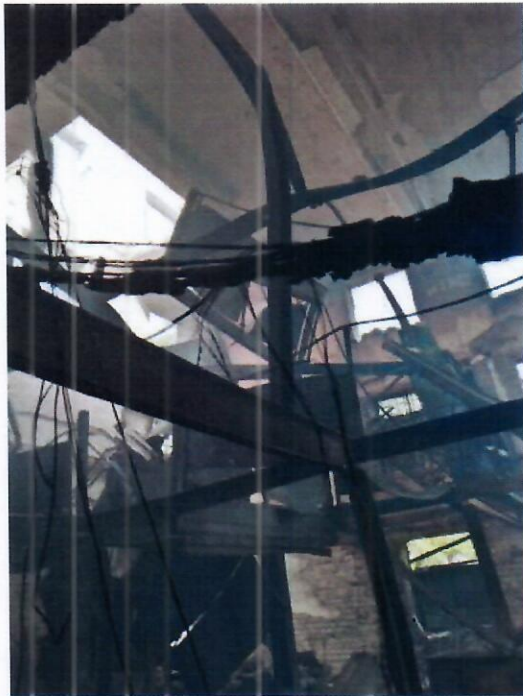
The building had metal conduit and steel beams shown in Figure 12 and Figure 13. The first floor had two levels whose floors collapsed as shown in Figure 13.

Figure 12: Hanging Metal Conduit, Burnt Trunking and Steel Beams in Southern Wing of Main Building

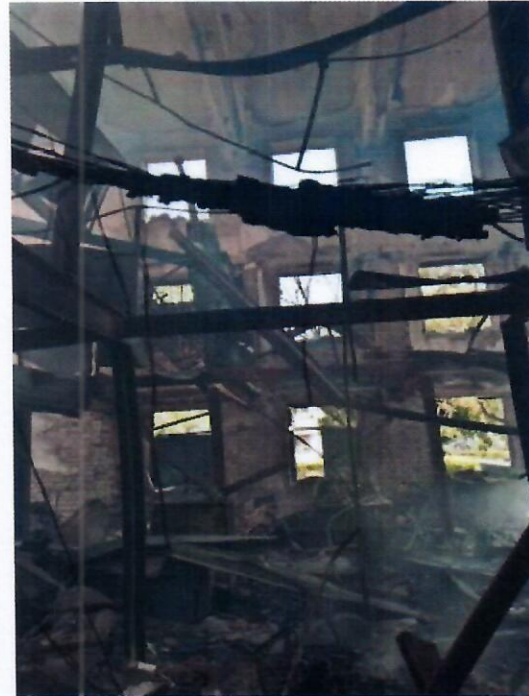
Figure 13: Burnt Out Ground and First Floor of Southern Wing of Main Building

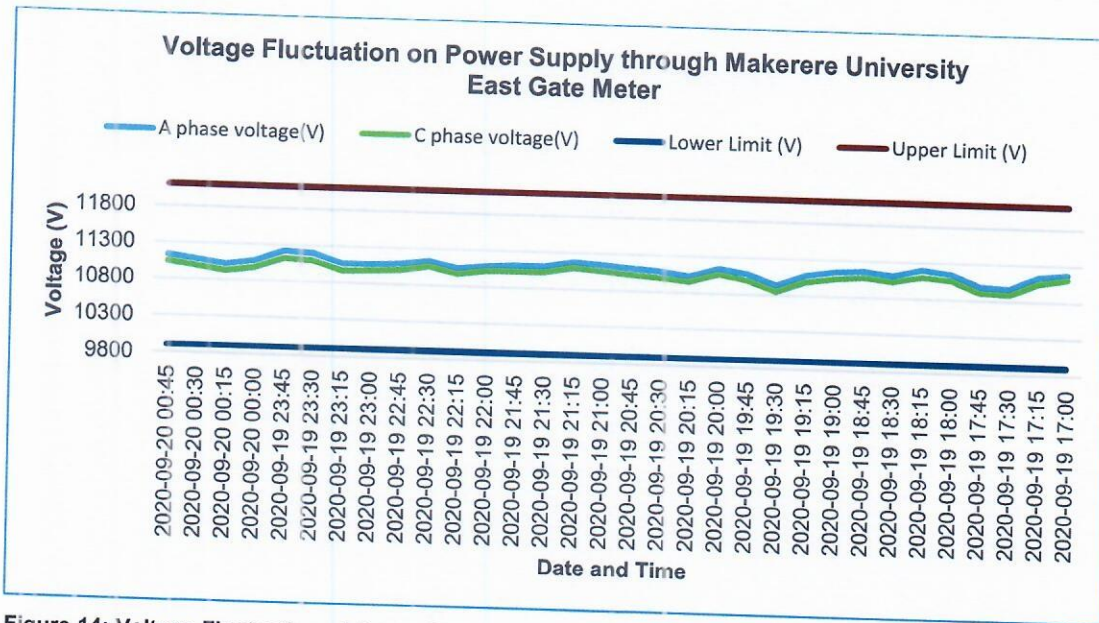
Data from the Umeme Ltd. bulk supply meters of Makerere University was obtained to check that the fire was not caused by over voltage from the mains power supply. There are two bulk supply meters at Makerere University, one at Makerere University East Gate and another at Makerere University School of Education. Voltage fluctuation on both meters was checked from the data. The data showed that the nominal voltage at the secondary of the transformer was maintained within $\pm 10\%$ from 5:00 p.m. on Saturday 19th September 2020 to 12:45 a.m. on Sunday 20th September 2020, at both meters, as per Section 8.3.1 of the Electricity (Primary Grid Code) Regulations, 2003. The fire was therefore was not caused by a voltage fluctuation from the mains power supply.

Figure 14: Voltage Fluctuation of Power Supply through Makerere University 1 Bulk Supply Meter at East Gate

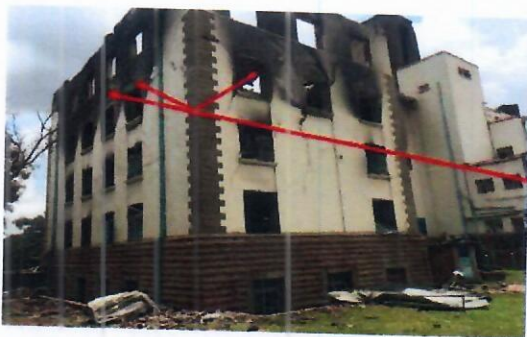
The soot deposition patterns on the windows of the first floor in the northern wing (see arrows in Figure 16) suggest intense burning happened on this floor. Fire burns upwards implying that flames appear to have been ignited on this floor and spread upwards and southwards rapidly reaching the second floor and roof through a staircase. The staircase through which the fire spread is shown in Figure 17.

Figure 16: Soot Deposition Pattern in Windows on First Floor of Northern Wing of Main Building

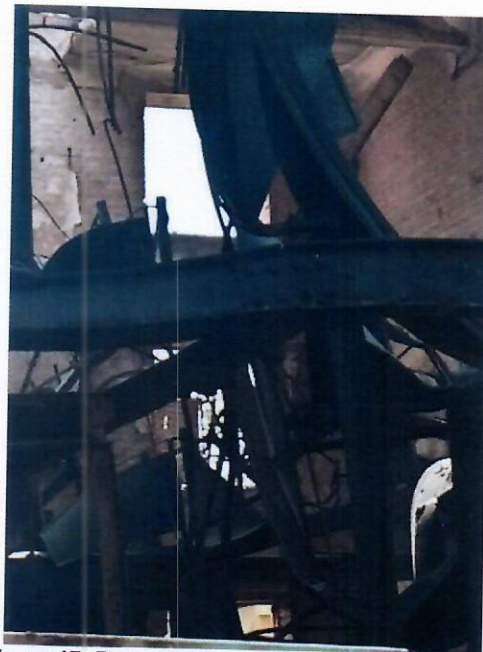
Figure 17: Burnt Staircase of First Floor, Northern Main Building

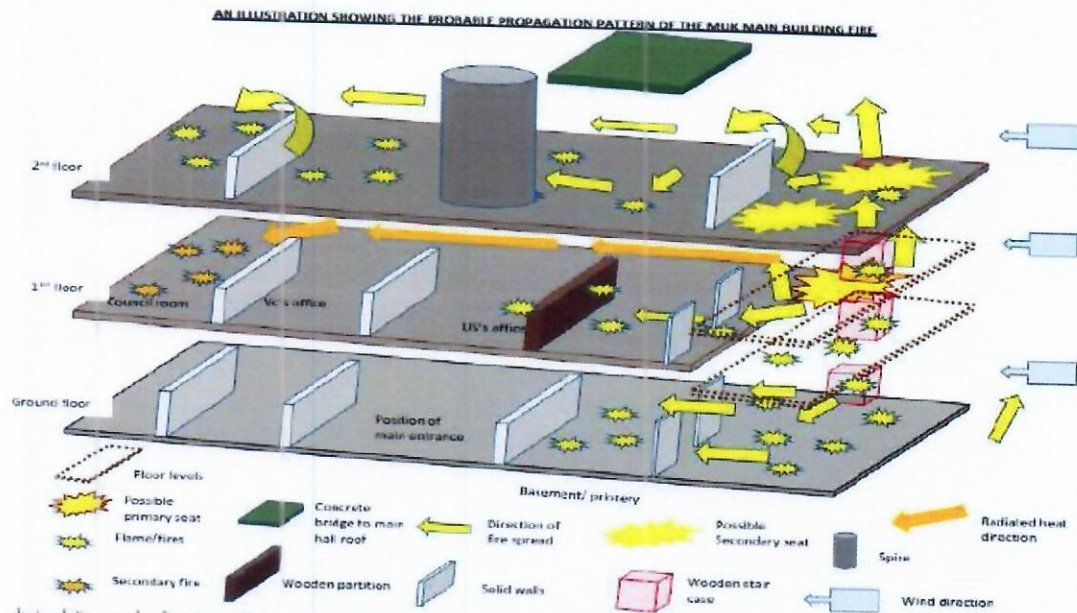
The origin of the fire is confirmed as an area within the northern wing of the Main Building, i.e. the University Bursar's office or Room 315, where his secretaries sit. The fire spread to adjacent offices upwards in a V shape and southwards following ambient wind direction (southwards). The fire moved along the wooden staircase to the second floor of the building. The roof dropped burning debris which introduced fires in the other offices of the second floor away from the northern wing of the building. Heat was radiated by wind through the corridor and trunking on the first floor, to the Council Room. Fire spread from the northern wing of the building to the Central Registry, destroying most of the property there.

Figure 18 is an illustration of the propagation pattern of the fire at Makerere University Main Building. The origin of the fire is confirmed as an area within the northern wing of the Main Building, i.e. the University Bursar’s office or the Room 315, where his secretaries sit. The fire spread to adjacent offices upwards in a V shape and southwards following ambient wind direction (southwards). The fire moved along the wooden staircase on the second floor of the building. Figure 18 shows that the roof dropped burning debris which introduced fires in the other offices of the second floor away from the northern wing of the building.

Figure 18: Illustration of Propagation Pattern of Fire at Makerere University Main Building

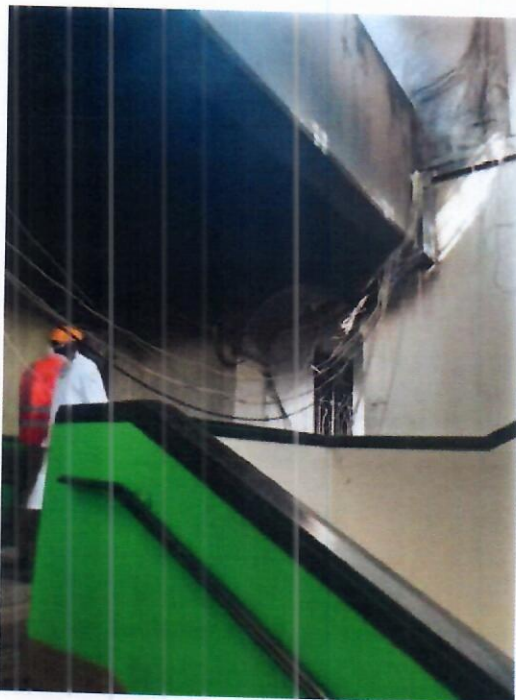
The second fire that occurred on Sunday 20th September 2020 was caused by heated trunking. Heat was radiated by wind through the corridor and trunking on the first floor, to the Council Room. Trunking was run from the northern wing to the southern wing on the first floor, at ceiling level. The trunking was heat conducting. The trunking reached a very high temperature resulting in ignition and burning of the Council Room on the first floor of the building. Figure 19 shows exposed wires from the burnt PVC trunking in the corridor of first floor.

Figure 19: Exposed Wires from Burnt PVC Trunking in Corridor of First Floor of Main Building

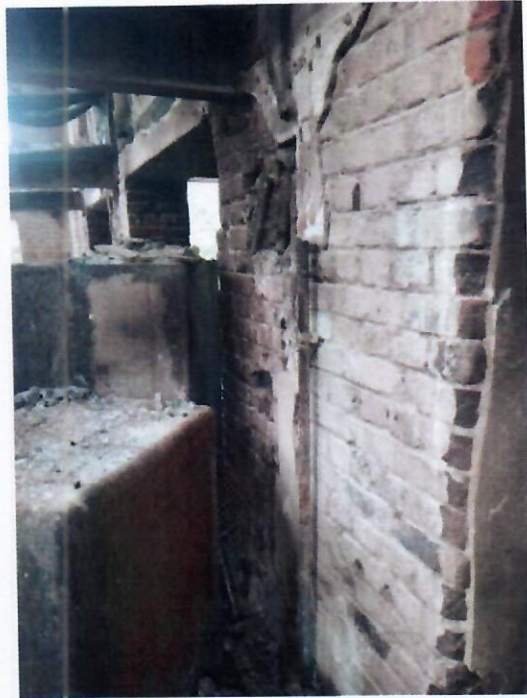
There were three consumer's units in the finance office supplying power to the finance office in the northern wing of the building, and all offices above the finance office up to the second floor of the northern wing of the building. Figure 25 shows the position of the burnt consumer's unit in the finance office in the northern wing of the Main Building. Figure 26 shows the burnt consumer's units of the ground floor of northern wing. Figure 27 shows the position of the second burnt consumer's units on the ground floor of the northern wing. The three consumer's units had circuit breakers.

Figure 25: Position of Burnt Consumer's Unit in Finance Office in Northern Wing of Main Building

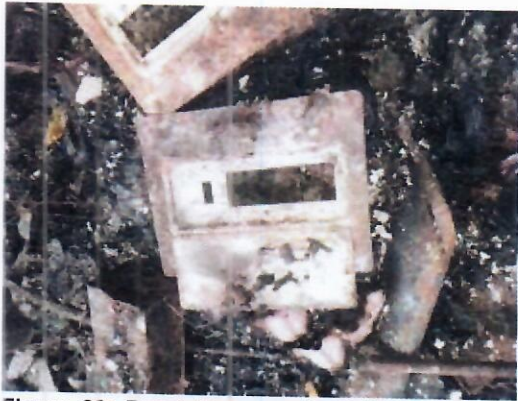
Figure 26: Burnt Consumer's Units of Ground Floor of Northern Wing of Main Building

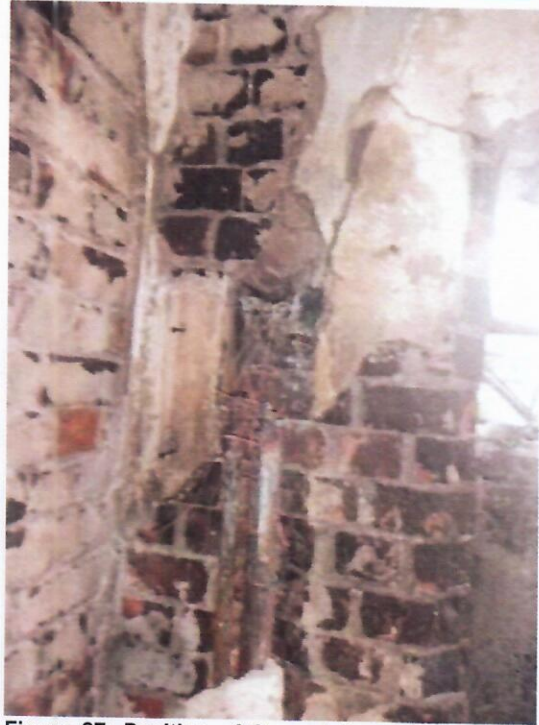
Figure 27: Position of Second Burnt Consumer's Units on Ground Floor of Northern Wing of Main Building

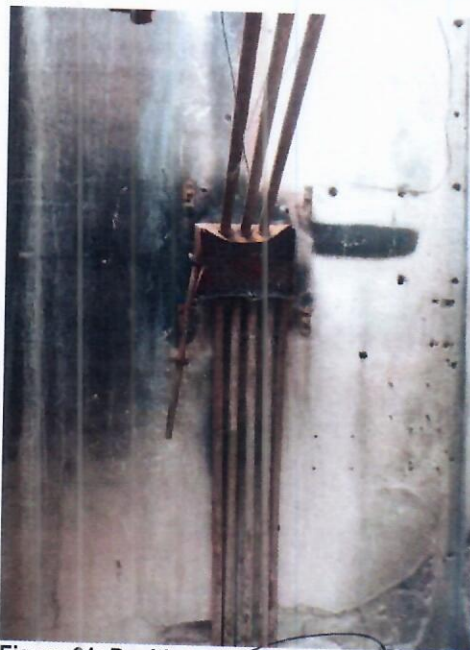
There were two consumer's units on the second floor of the Main Building supplying power to the second floor of the Main Building. One was supplying power to sockets and the second was supplying power to lights. Figure 31 shows the position of the burnt consumer's units for lights and sockets on second floor of the Main Building. The consumer's units on the second floor had fuses and not circuit breakers.

Figure 31: Position of Burnt Consumer's Units for Lights and Sockets on Second Floor of Main Building

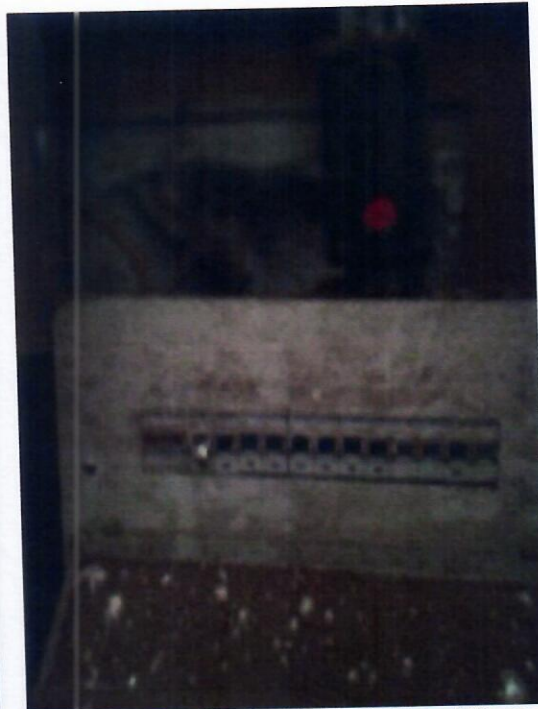
There are two consumer's units in the ceiling above the stage of the main hall, shown in Figure 32 and Figure 33. It was not clear how these consumer's units were supplied with power. These consumer's units had fuses, not circuit breakers.

Figure 33: Consumer's Unit 2 in Ceiling of Stage of Main Hall
