INVESTIGATION REPORT INTO CAUSE OF FIRE AT MAKERERE UNIVERSITY MAIN BUILDING

Task Force on the Cause of Fire at
Makerere University Main Building

November 2020

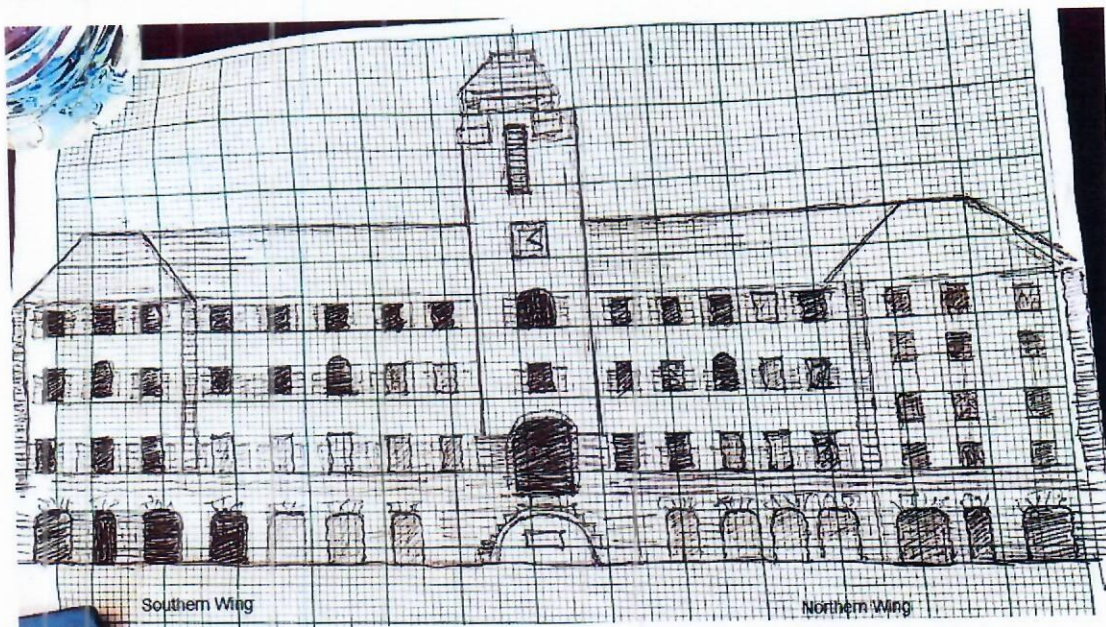
Figure 1: Sketch of Makerere University Main Building Front View

Makerere University Main Building was a three storied building with two wings, a basement, a tower and a main hall. There was printery in the basement of the building. The northern and southern wing of the building were separated by the tower. The first floor of the northern wing of the building had a mezzanine level with a concrete floor. The other floors of the northern and southern wing of the building were wooden, except for the corridors that had concrete floors. Figure 1 is a sketch of the Main Building's front view.

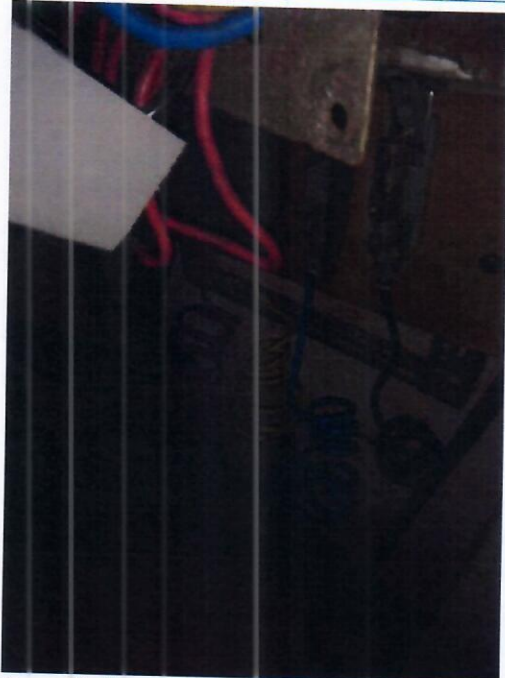
Figure 20: Fuse Cut Outs at Main Incomer of Main Building

Three phase power is supplied to the Main Building from a feeder pillar near the Faculty of Food Science and Technology. The power enters the Main Building in a power room found in the printery of the Main Building. There is a fuse in the feeder pillar for the power supply to the Main Building. The power goes through three cut out fuses (shown in Figure 20) in the power room, to a busbar (Figure 21).

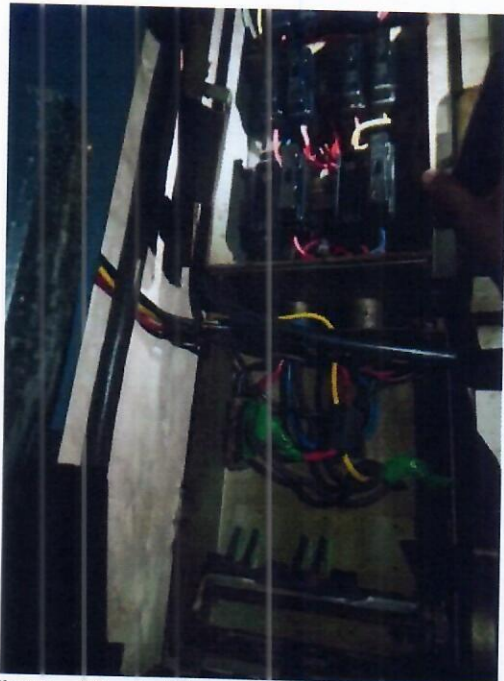
Figure 22: Isolators for Power Supply to Consumer's Units in Basements and Floors of Main Building

Power is tapped from the busbars to each of the three floors and the basement, through isolators (Figure 22), except for power supply to one consumer's unit on the ground floor which taps power through a Main Distribution Board (MDB) (see Figure 23). The Main Distribution Board had circuit breakers. The sizing of the circuit breakers may not have matched the loads on the circuits as the electricians could not tell which circuits were supplied from the MDB.

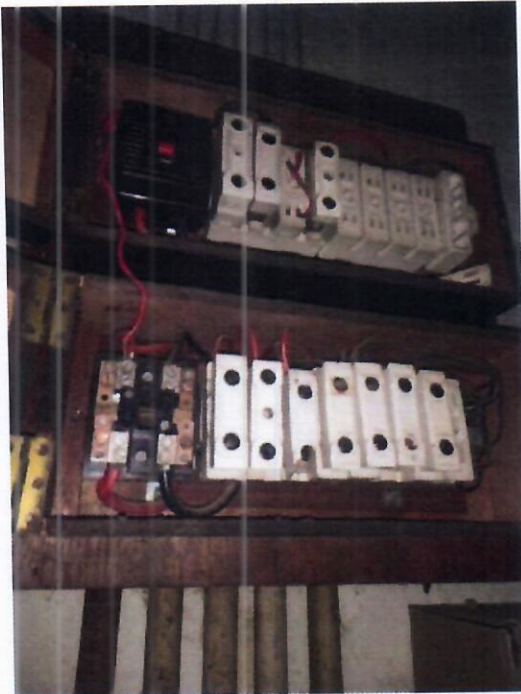
Figure 24: Consumer's Unit in Duct Supplying Power to Section of Ground Floor of Northern Wing of Main Building

There were six consumer's units on the ground floor of the Main Building. There were two consumer's unit in the duct of the ground floor that supplied power to a section of the ground floor of the northern wing (Figure 24), one supplied power to the sockets and the other supplied power to the lights. These consumer's units did not have circuit breakers but had fuses. It is not certain that the wires of the fuses were sized correctly for the loads on the circuits. This is because the electricians would replace the wires when they got burnt with wires whose cross-sectional area they did not know.

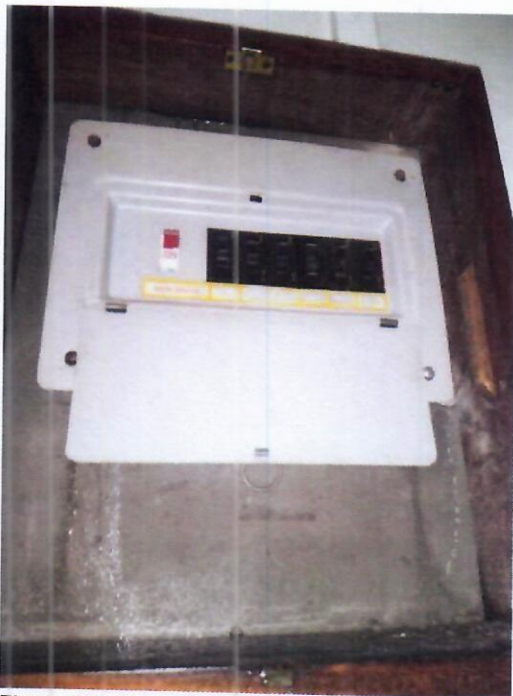
Figure 28: Consumer's Unit in Common Room on Ground Floor, Southern Wing of Main Building

The sixth consumer's unit is found in the Common Room in the southern wing of the Main Building (Figure 28). The sixth consumer's unit had fuses.

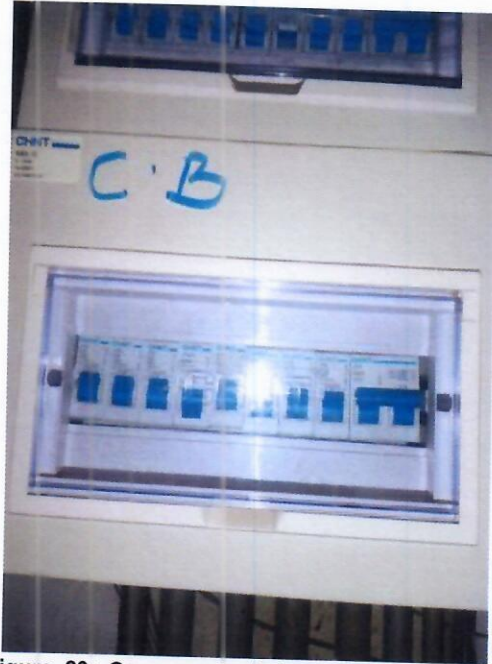
Figure 29: Consumer's Unit for Lights on First Floor of Main Building

There are two consumer's units on the first floor of the Main Building supplying power to the first floor of the Main Building. One supplies power to lights on the first floor (Figure 29) and the second supplies power to sockets on the first floor (Figure 30).

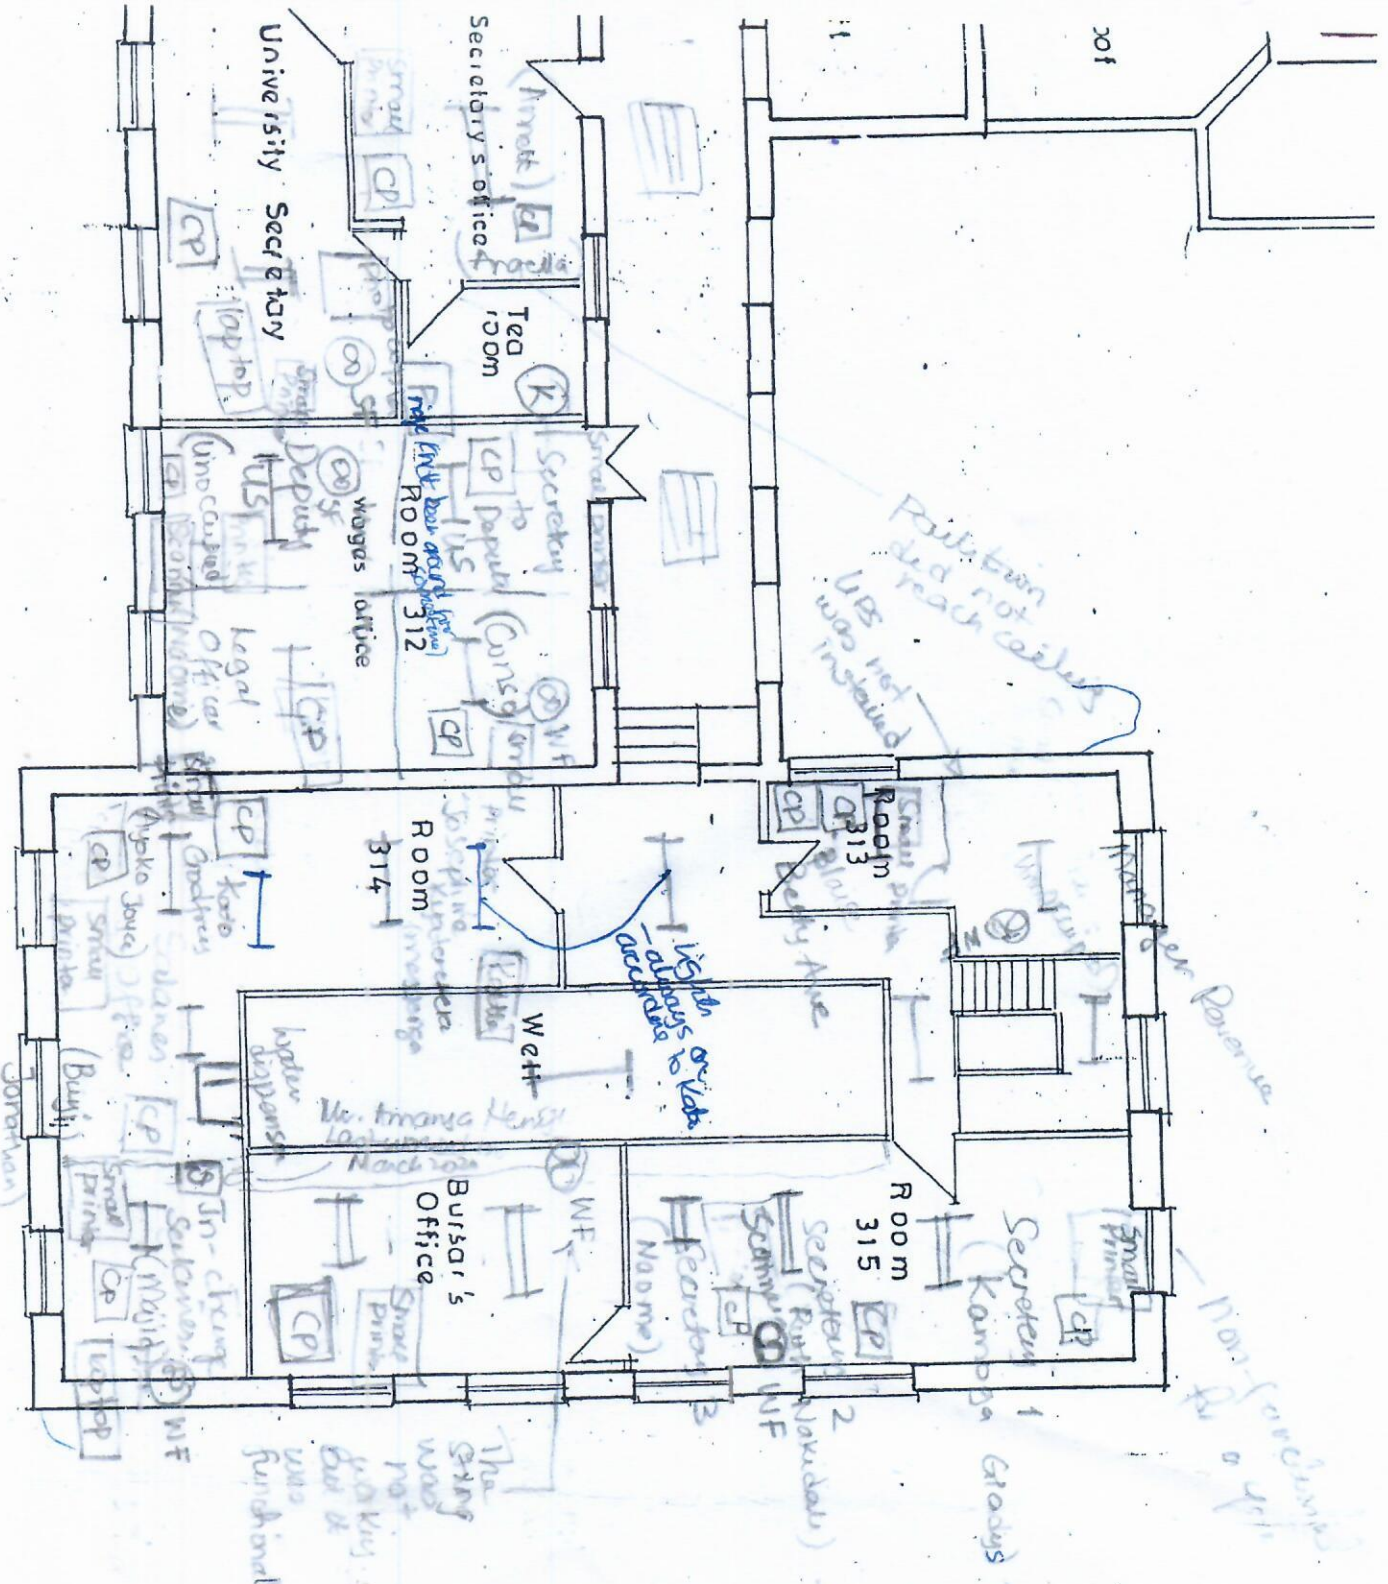
Annex 5: Sketch of Electrical Equipment in Offices on First Floor of Main Building

Paintwork did not reach ceiling
 UBs not installed
